VOICES FROM SMALL PLACES HISTORIC SURVEY

Project #	CRHR-001	Property #	009
County	Shelby	City	Arcadia
Address	FM 1645		
Recorded By	Kelley Snowden	Date	7/25/2014
Current Name	Prince Homeplace		
Historic Name			
Date Const		Estimated	
Actual		Modified	
Roof Type	<input checked="" type="checkbox"/> Gable <input type="checkbox"/> Gambrel <input type="checkbox"/> Flat <input type="checkbox"/> Hipped <input type="checkbox"/> Shed <input type="checkbox"/> Other		
Roof Materials	<input type="checkbox"/> Wood Shingles <input type="checkbox"/> Tile <input type="checkbox"/> Other <input type="checkbox"/> Composition Shingles <input checked="" type="checkbox"/> Metal		
Roof Condition	<input type="checkbox"/> Excellent <input type="checkbox"/> Good <input type="checkbox"/> Fair <input checked="" type="checkbox"/> Poor <input type="checkbox"/> Bad

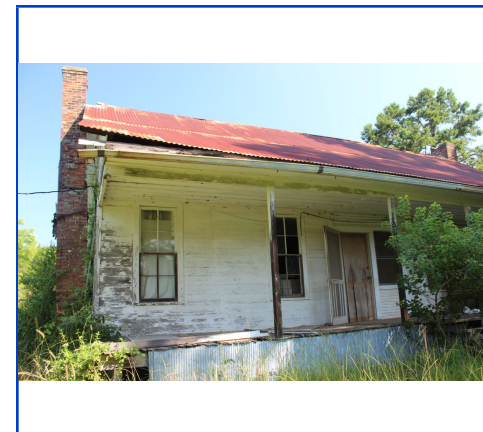
Notes: Originally probably had a double front door, but half has been boarded up and made into a window. Probably a dogtrot format with four enclosed rooms. There are two 1950s outbuildings in back, a mobile home, and a railroad shipping container.
